**TEST REPORT ON INFRARED
WARNING RECEIVER (IRWR) FLIGHT
VIBRATION MEASUREMENTS**

REPORT NO: AFWAL/FIBG/79-10

TYPE OF TEST: Airborne Vibration Measurements

This test report presents data which define the vibration environments experienced by two infrared warning receiver (IRWR) units mounted on the HH-53 helicopter and the C-130E transport aircraft.

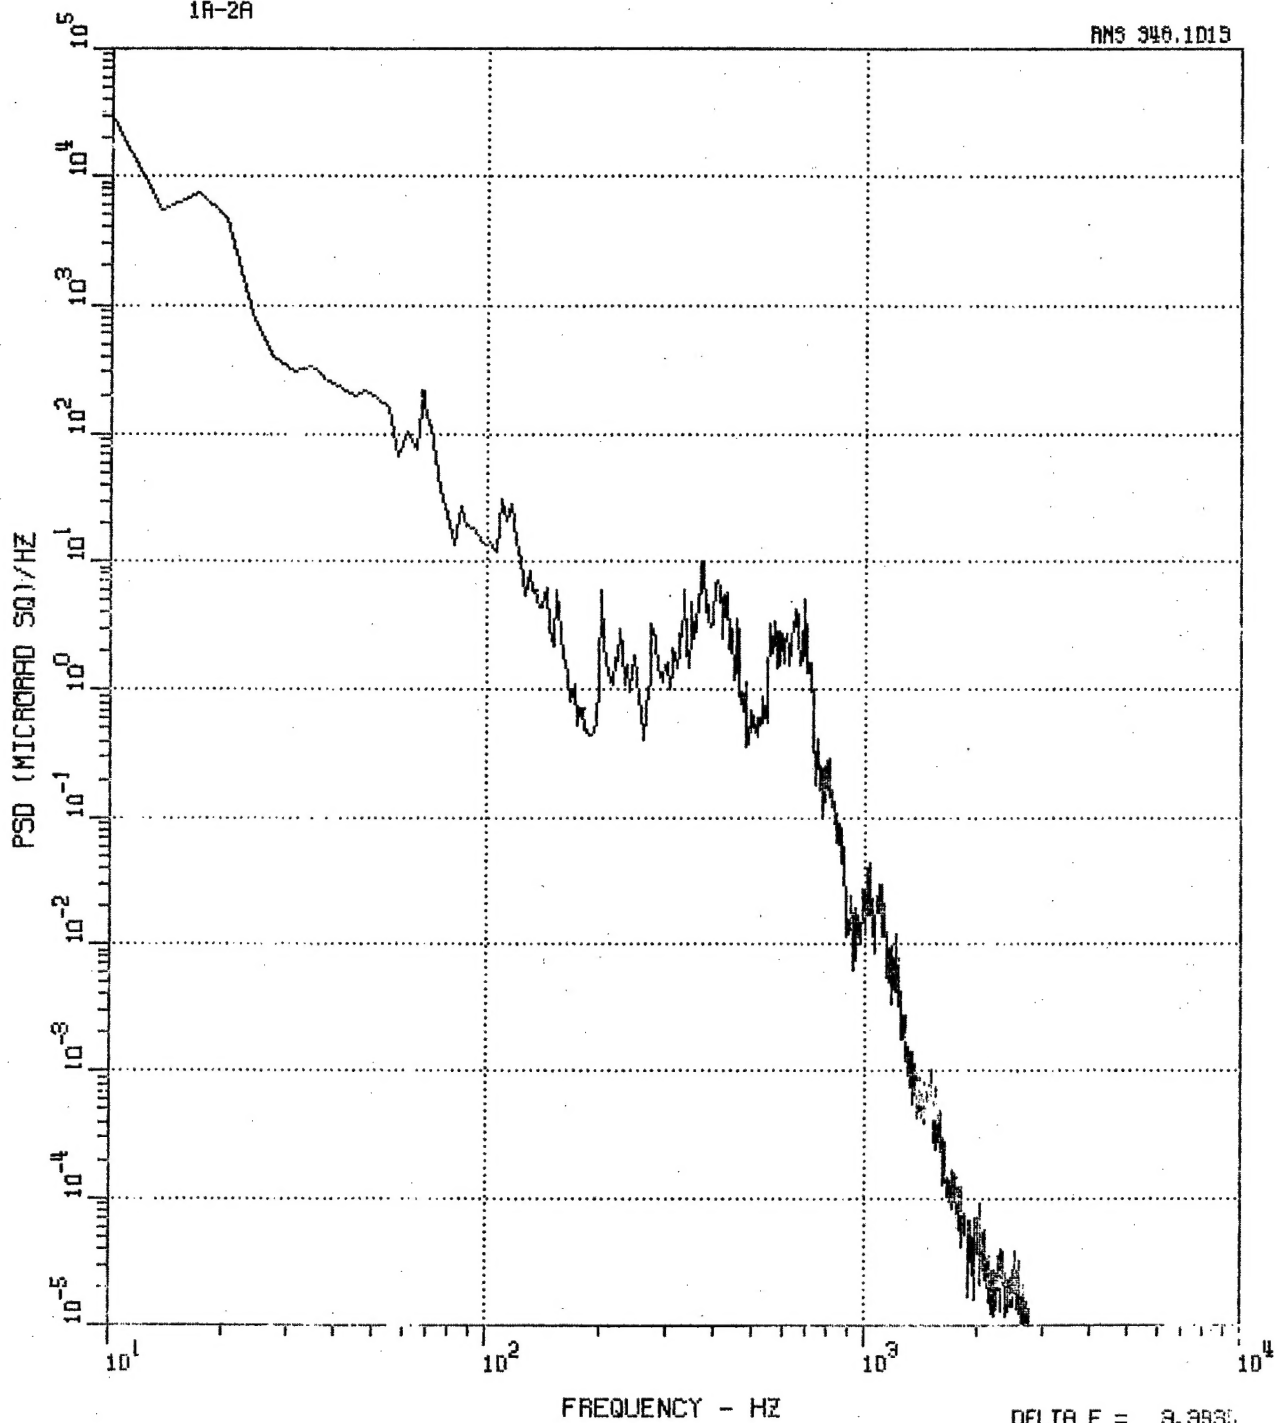
Figure 99. C-130 Aft Roll PSD, 1A-2A, 1000 Ft, 250 Kt, 30 Deg.

Several pairs of linear accelerometer signals on the C-130 were combined to produce a measure of the angular accelerations experienced by the sensors. The sensors chosen are shown in Table 7 and the results are shown in Figures 96-100 for the selected flight condition of 250 knots, 30° bank, and 1000 feet altitude. The results, shown in PSDs of microradians squared per hertz, are for information only and were not used to evaluate the sensor vibration environments.

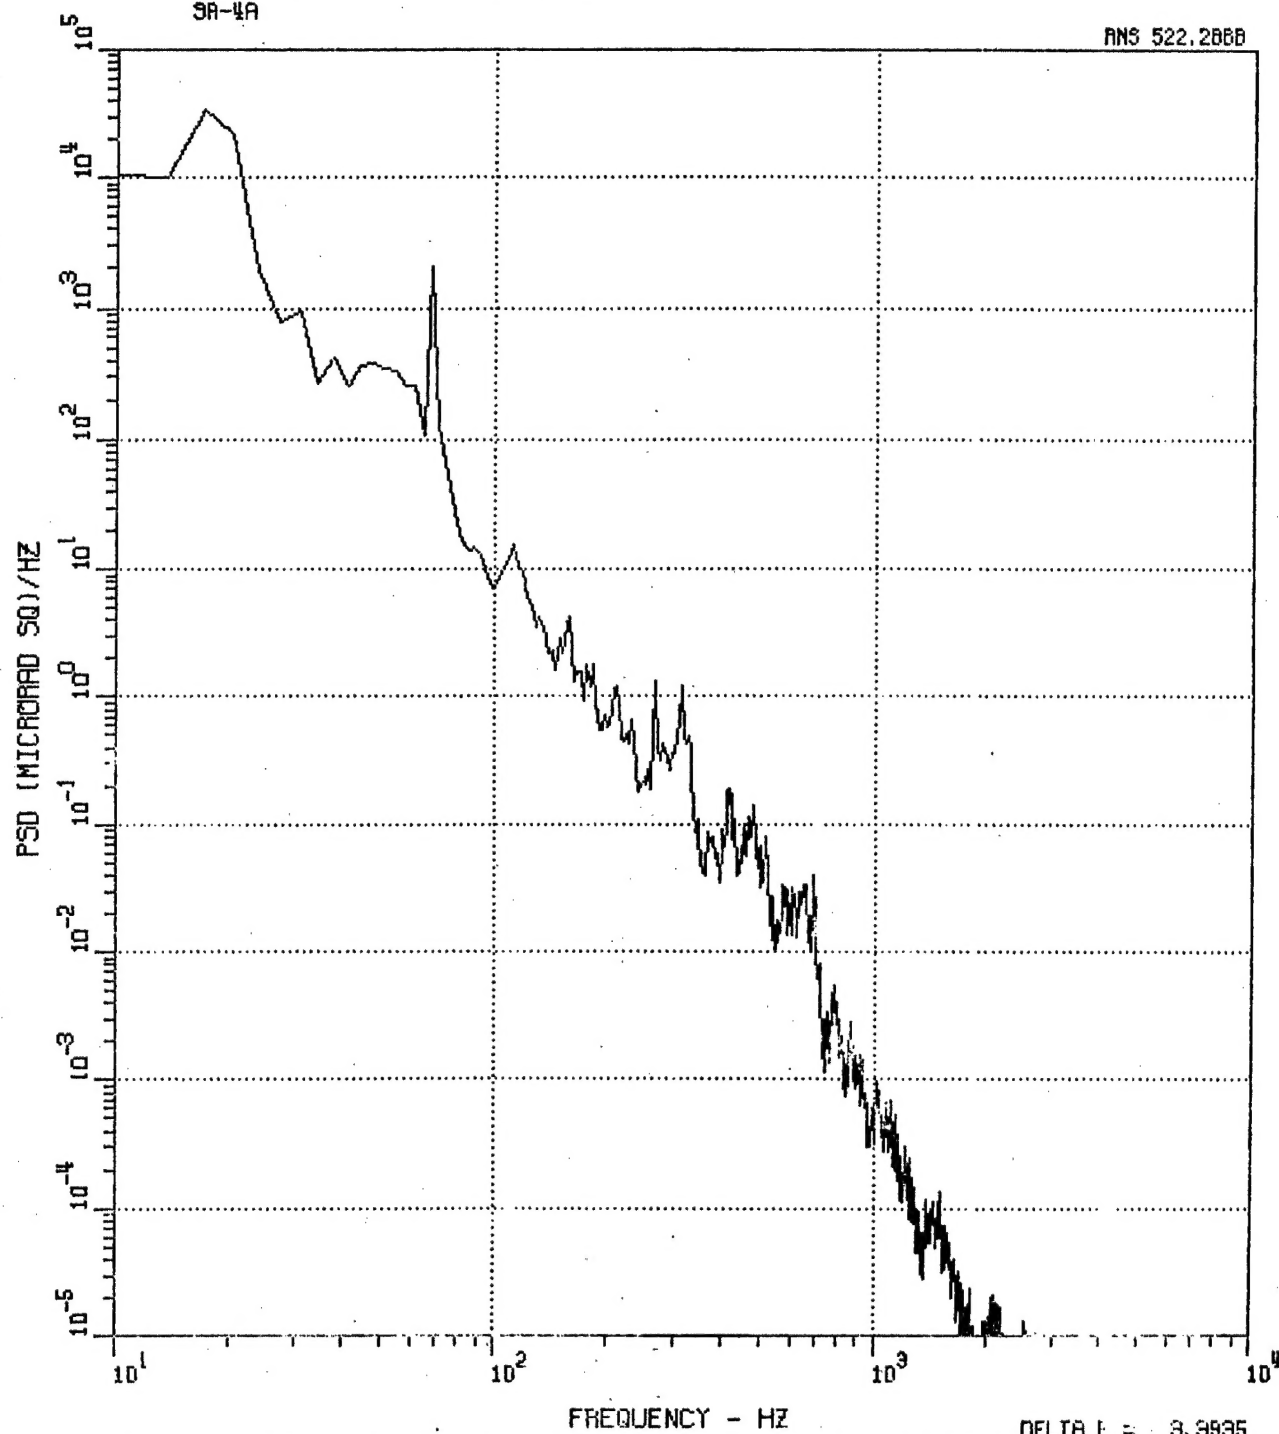
Figure 100. C-130 Aft Pieth. PSD, 3A-4A, 1000 Ft, 250 Kt, 30 Deg.
